Fw 190D

Walk Around Number 10
squadron/signal publications

By E. Brown Ryle and Malcolm Laing

Focke-Wulf Fw 190D-9

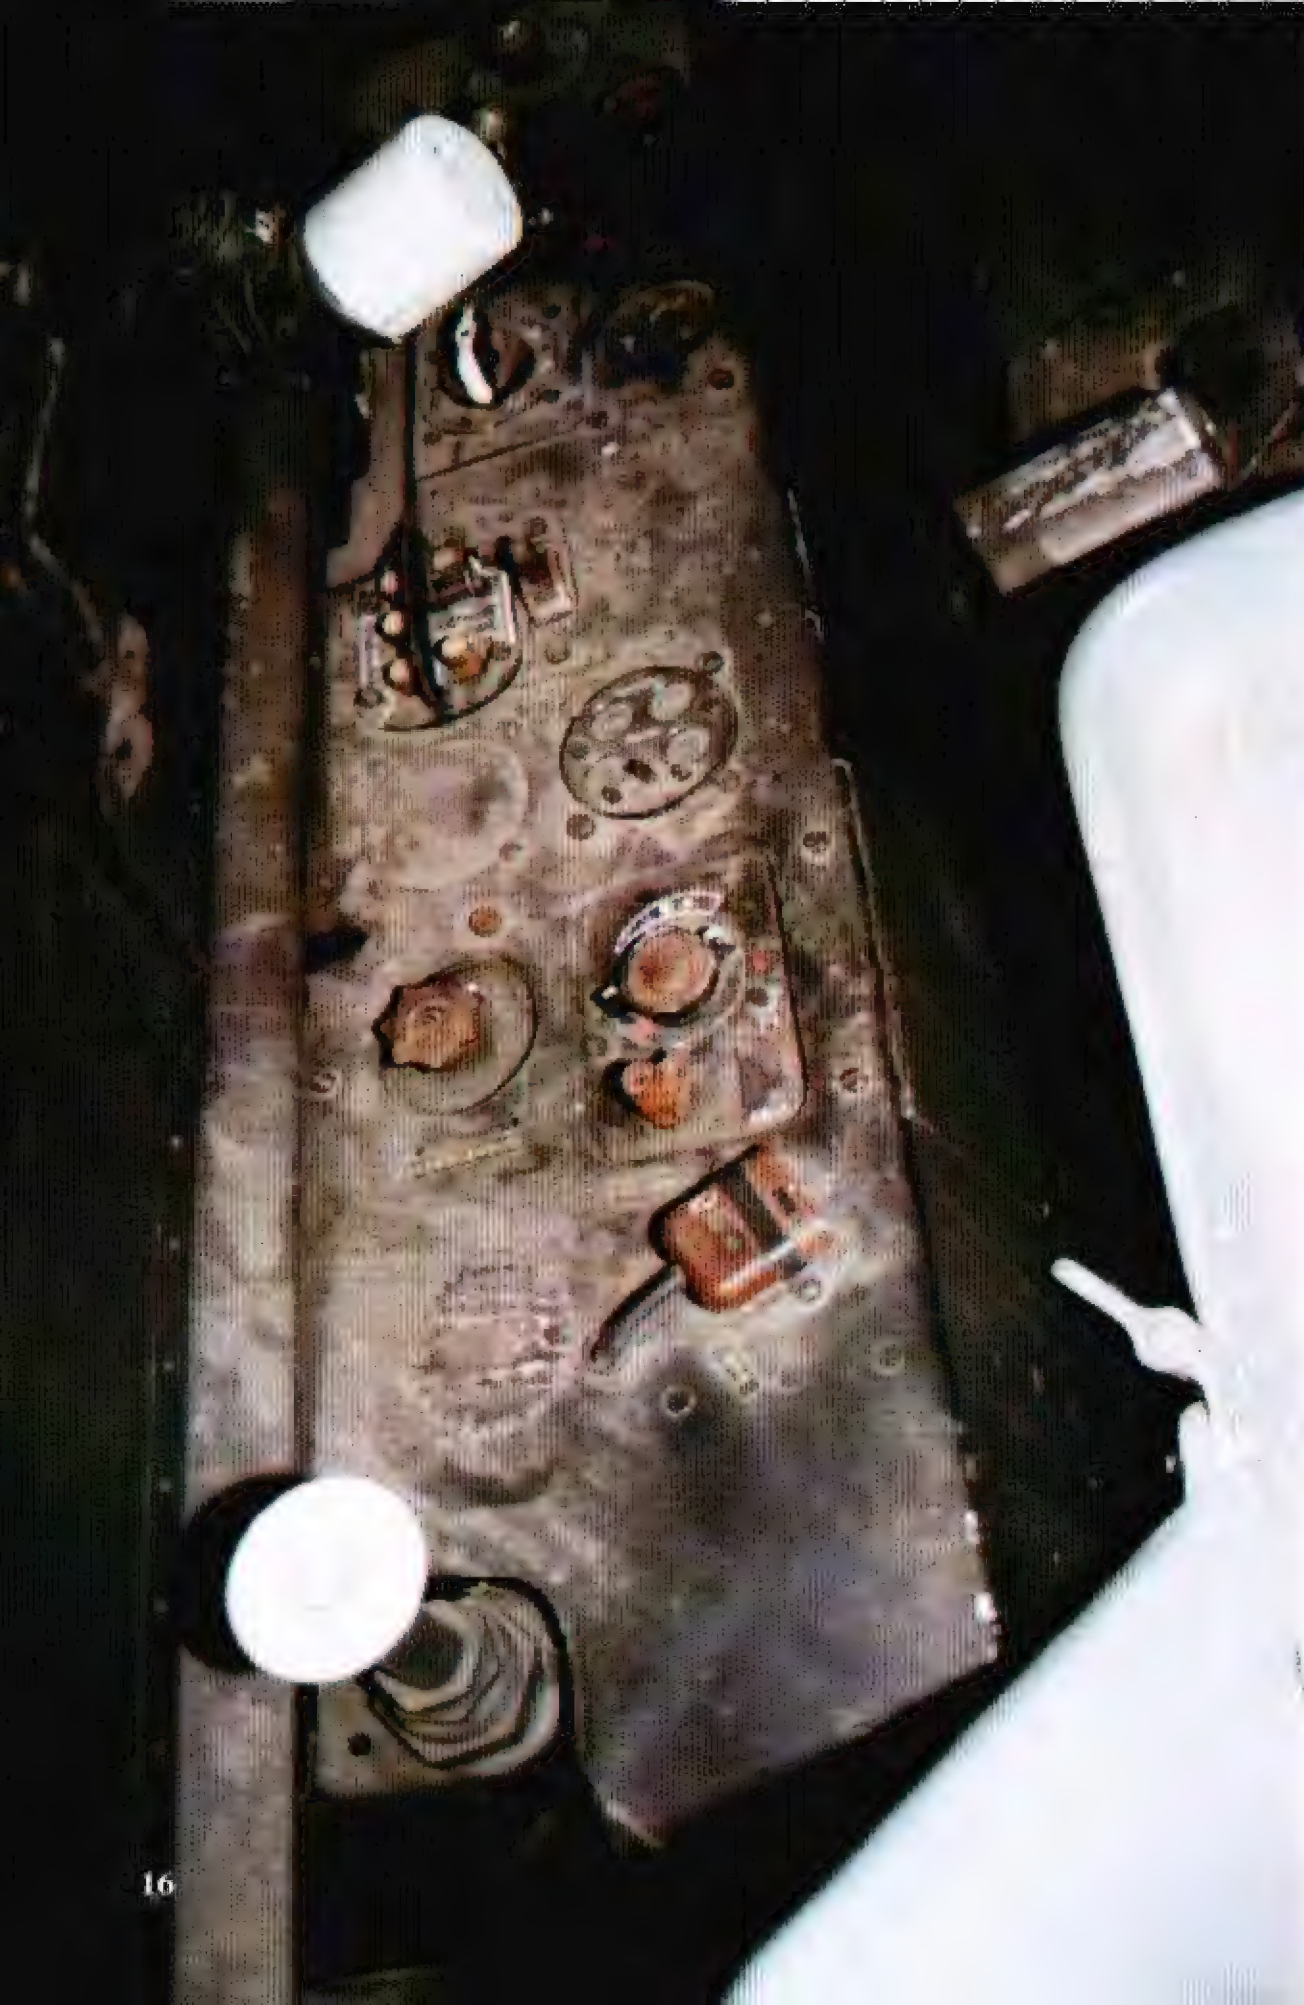
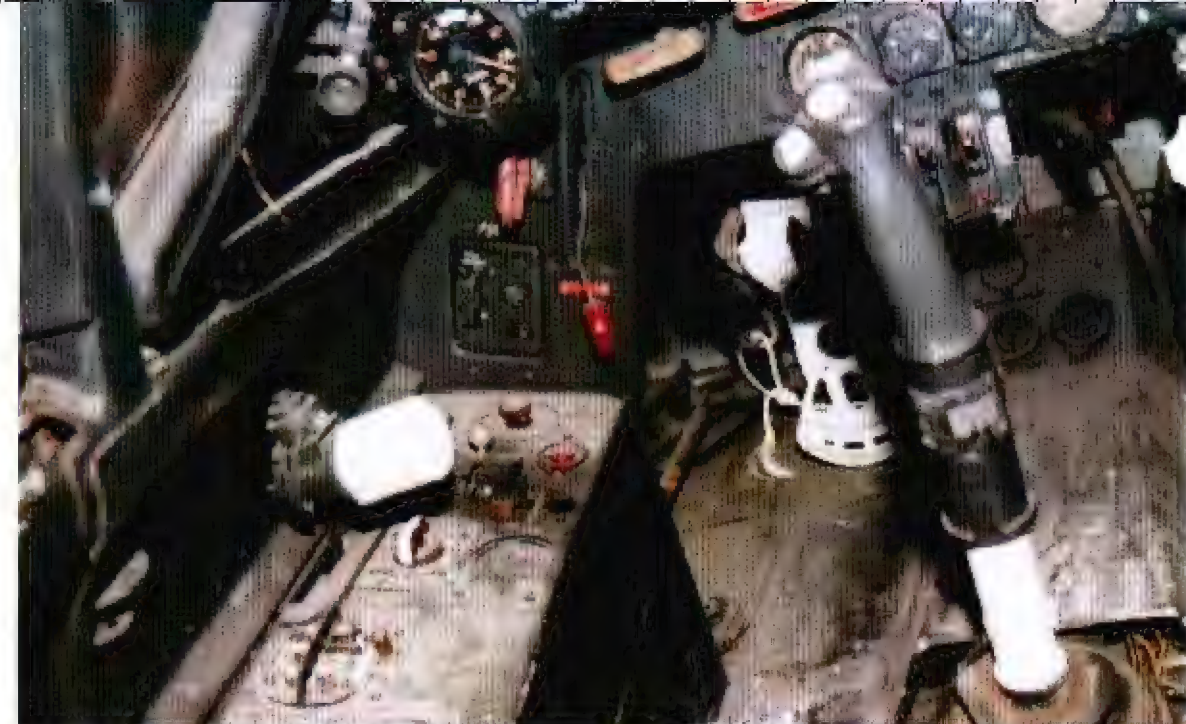
(Above) Forward of the throttle lever is the trim indicator, starter button, and the instrument light dimmer. On the lower instrument panel is the IFF panel, above that is the landing gear manual extension and the red knobbed handle is the manual fuel tank selector lever. (Author: Ryle)

(Left) The left console, like the right, is dusty, but original. The white knobbed plunger at the rear of the console is the primer fuel pump handle. The Brown plug-in forward of the primer is for the pilot's headset. The two turn knobs are controls for the FuG 16ZY radio. Further forward are the landing gear and flap actuator buttons with the horizontal stabilizer trim switch to their right. The large white knob is on the throttle lever. (Author: Ryle)

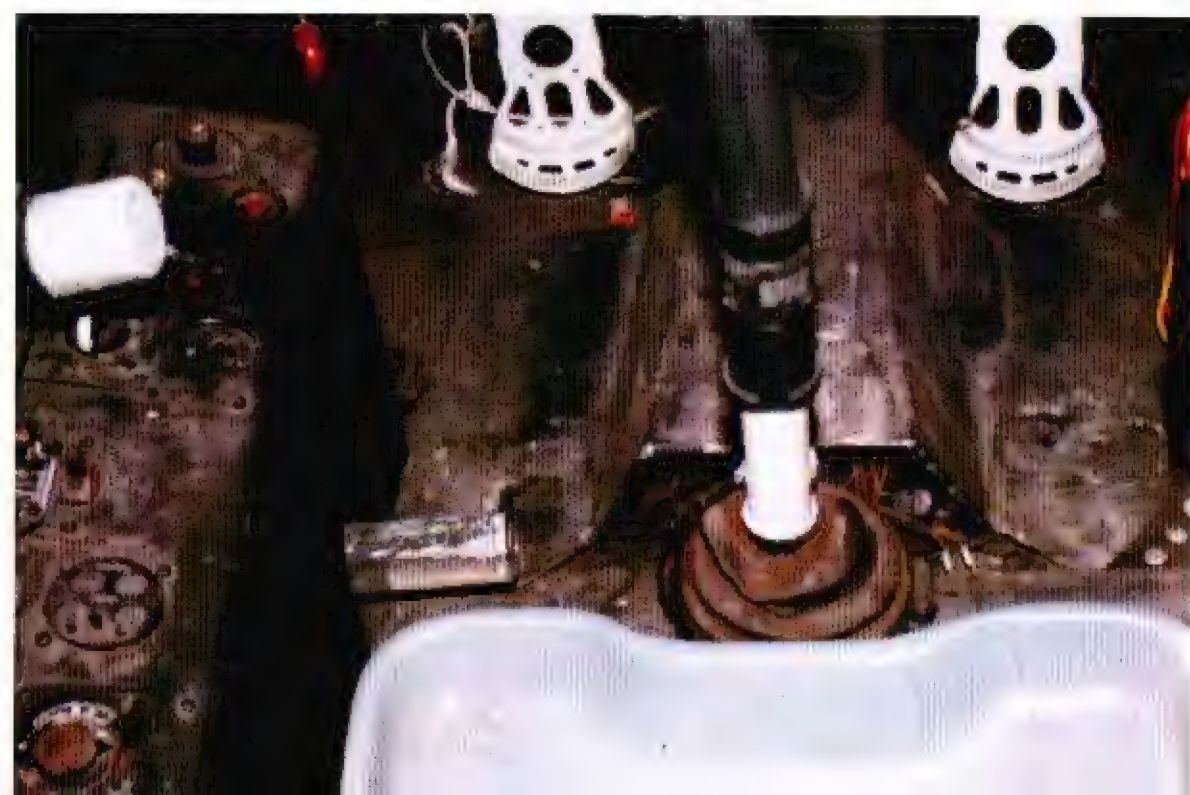
(Below) The throttle friction knob extends from the bottom of the left console. The control stick has a boot installed around its bottom just above the elevator control rod coming out of the boot to the right console. (Author: Ryle)

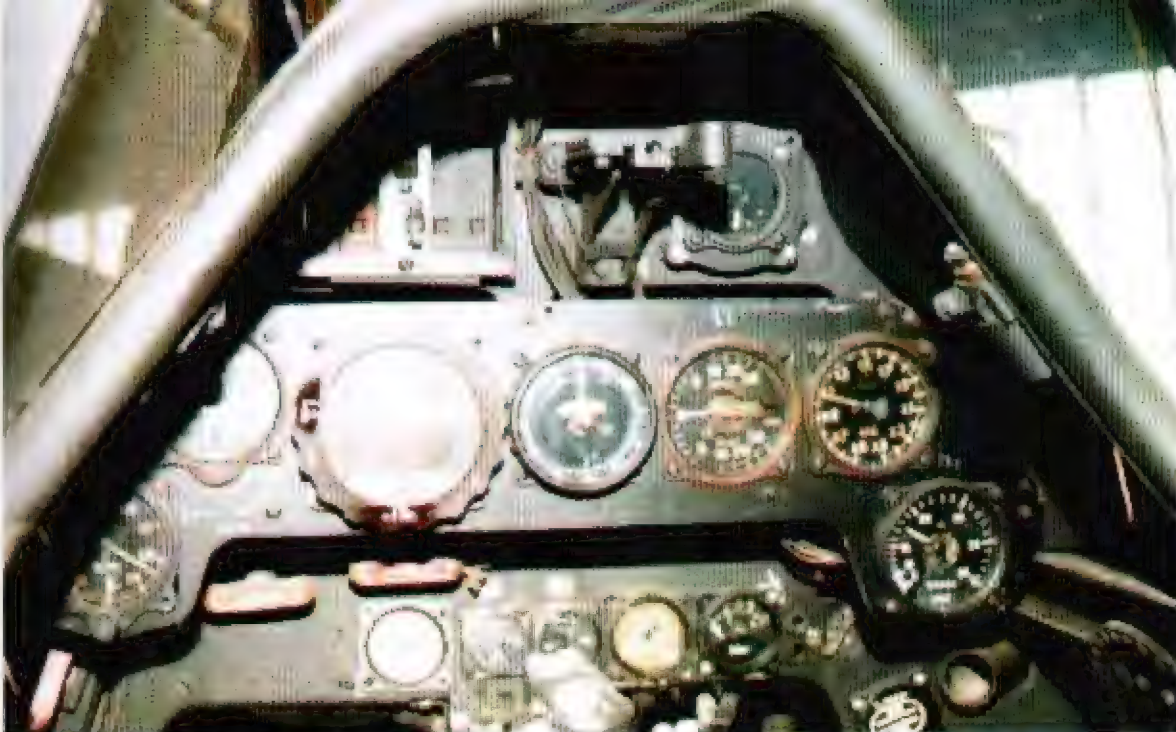
(Above) The upper and lower instrument panels are surrounded by a leather cushioned combing. On the upper left, just under the combing, are the ammunition counters (which are missing) and to the right of the counters is the Revi 16 gun sight (not installed) mount. To the right of the mount is the AFN 2 homing indicator used for instrument approaches. (Author: Ryle)

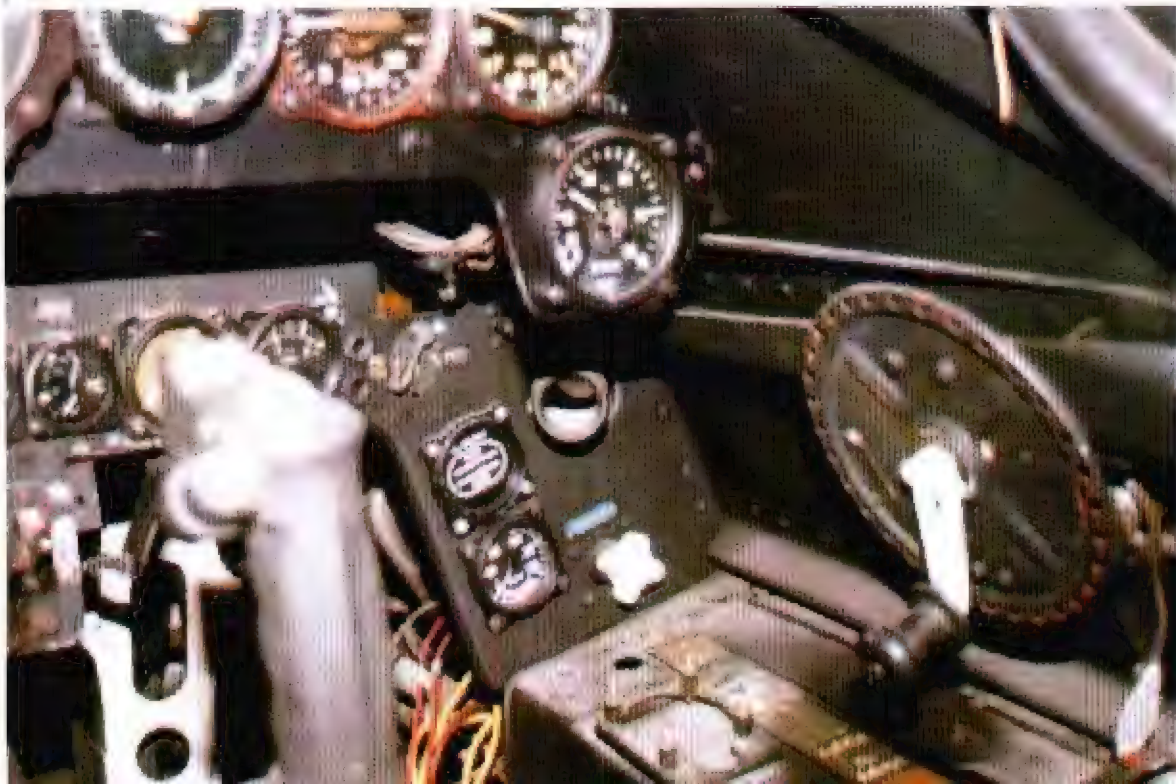
(Below) The forward right section of the Fw 190D-9 cockpit. The differences in the upper and the lower recessed instrument panel are well defined. On the right side of the lower instrument panel is the flare tube and the oxygen instrument group. The missing instrument on the lower panel just below and to the right of the flare chute is a clock (Author: Ryle)

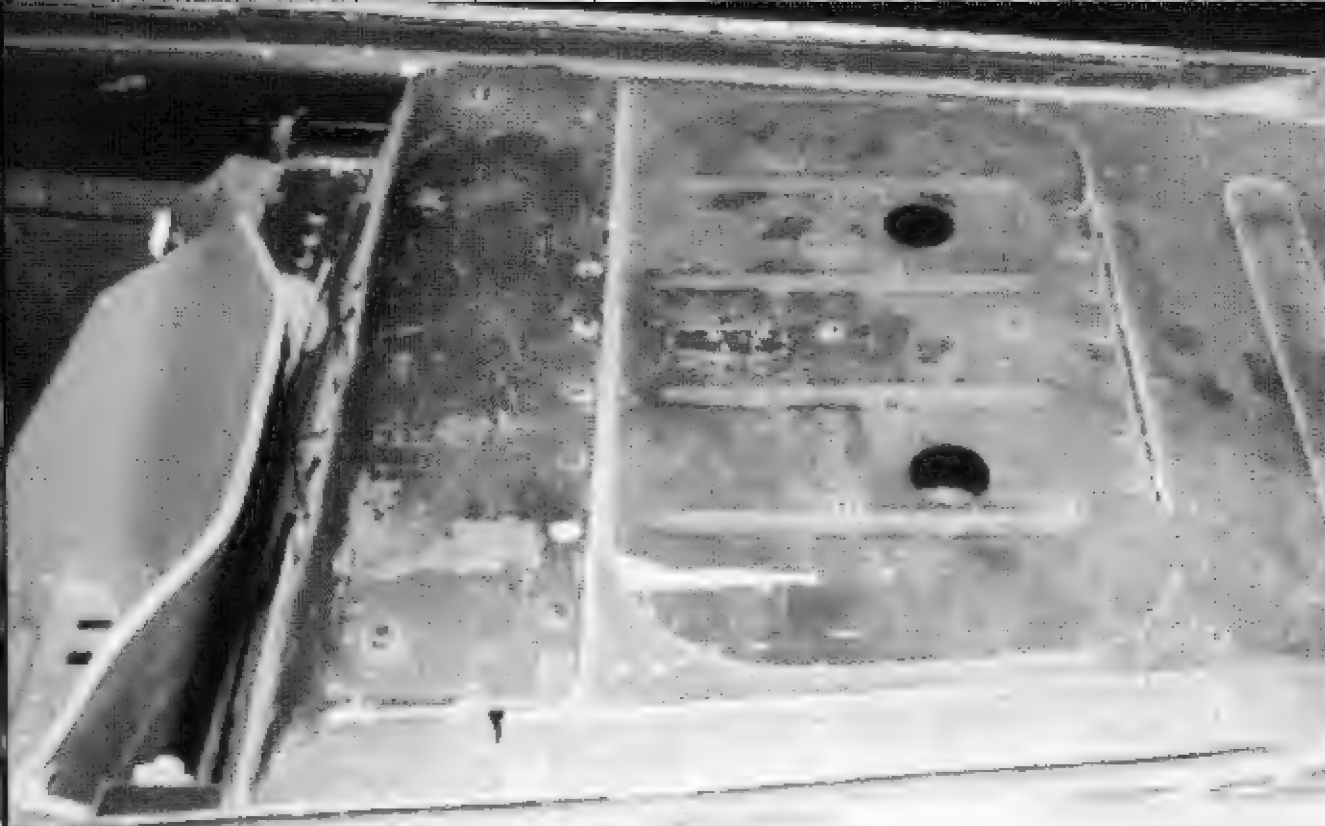
(Above and below) The decking at the rear of the cockpit, under which sits the radio equipment. The piece running across the rear of the cockpit immediately behind the seat is the 'shoulder armor' and is 5mm thick. The access door behind the shoulder armor can be opened and used as the pilot's storage compartment. This is one of several different styles of this door. (Author: Ryle)

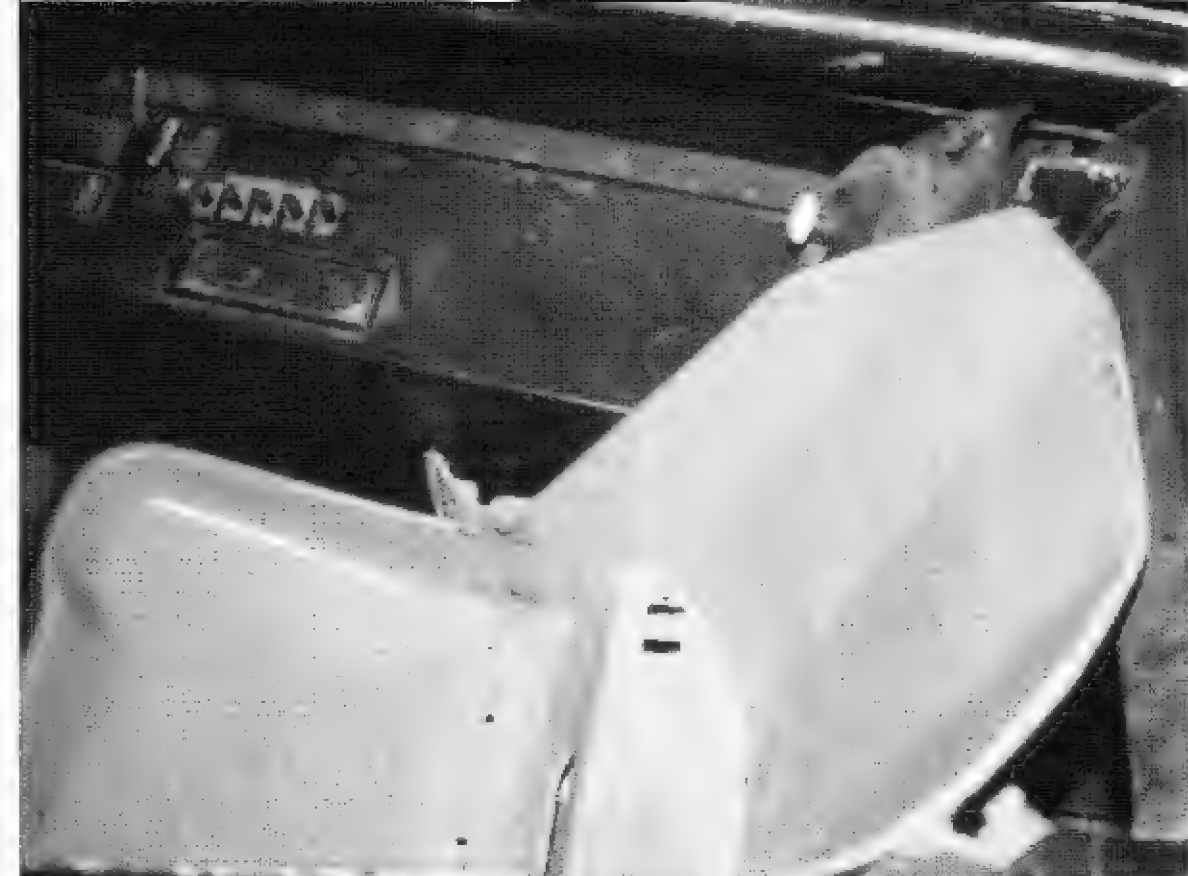
The seat was positioned at the very rear of the cockpit against the rear wall. The shelf built into the back supported the pilot's parachute. The white button to the right of the seat is the oxygen regulator. The canopy slide track can be seen above the seat. (Author: Ryle)

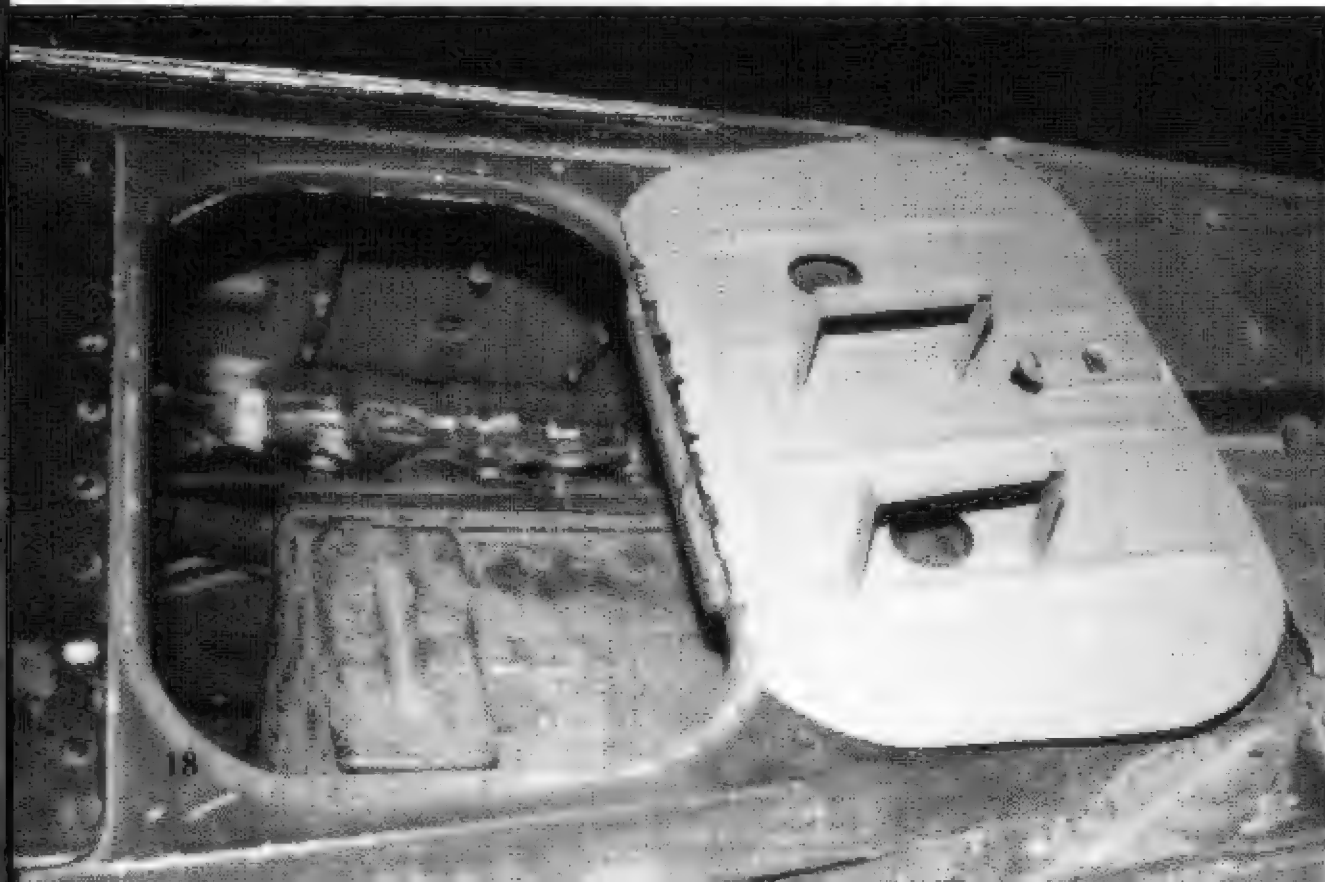
The shoulder strap attachment bars are bolted and riveted to the lower face of the shoulder armor plate just above the seat back. Both of these attachment bars face to the left; it is not known if this procedure was intentional, accidental, or due to wartime conditions. (Author: Ryle)

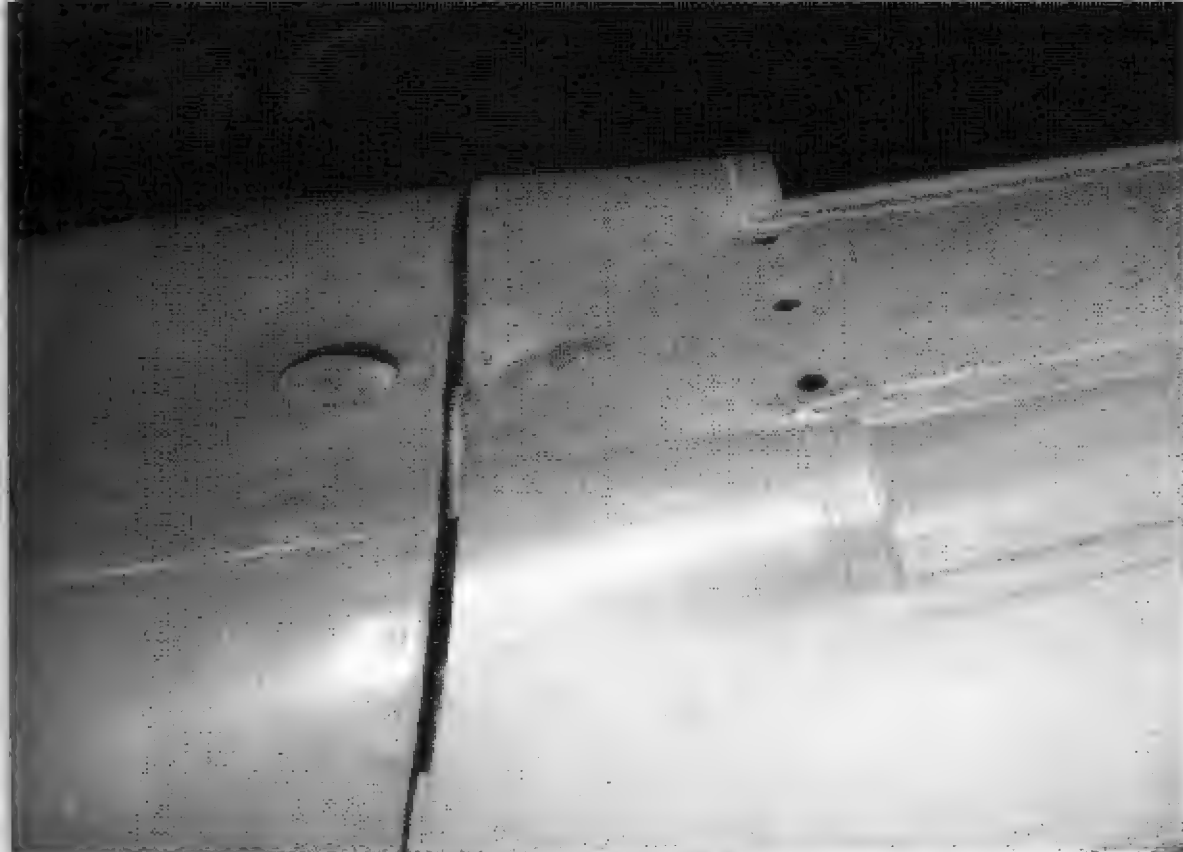
The upper engine panel has machine gun troughs welded in place. The hole at front of the bulged machine gun cover is for the engine starter crank. (J. Bishop)

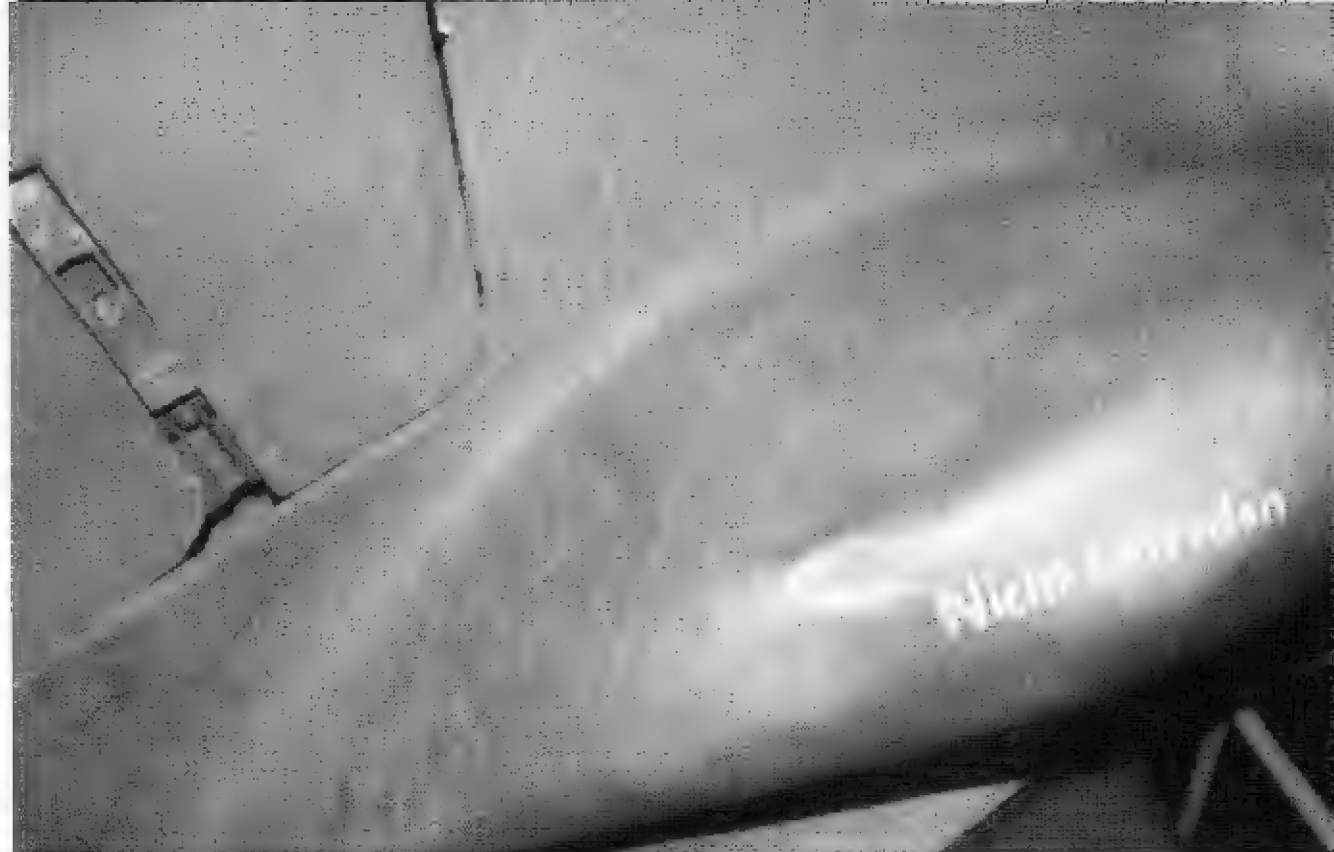
The bulged machine gun cover has two latches on each side. This cover was in three sections with the center section overlapping the outside sections and riveted together. (J. Bishop)

The weld line divides the supercharger intake into upper and lower halves. The words *Nicht betreten* translates as "No Step". (Author: Ryle)

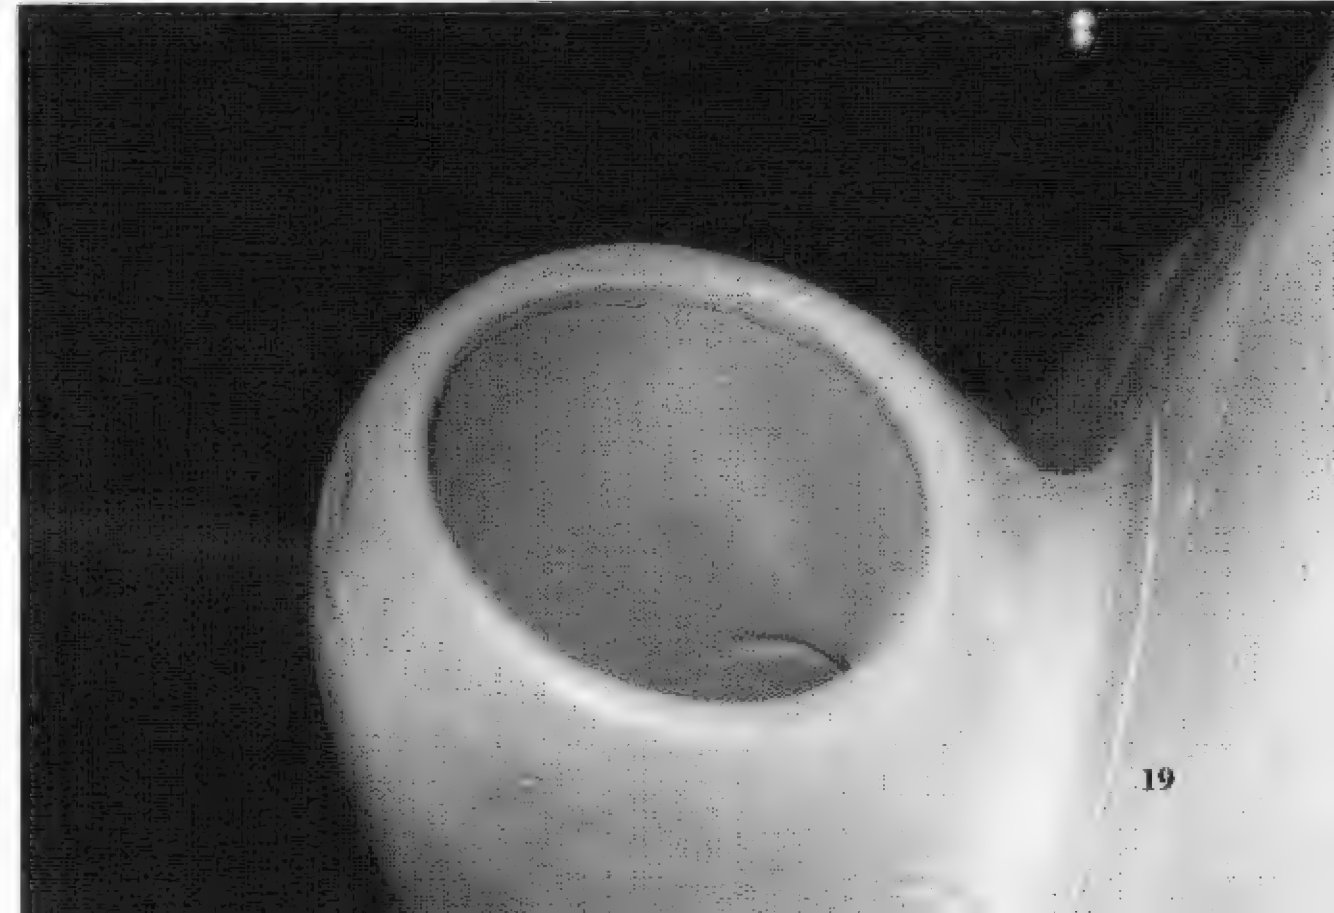
The Fw 190D series had the engine supercharger air intake on the starboard side of the fuselage. The intake's opening is perfectly round. The intake is made from several pieces of aluminum welded together and the completed assembly is flush riveted to the engine panel. (Author: Ryle)

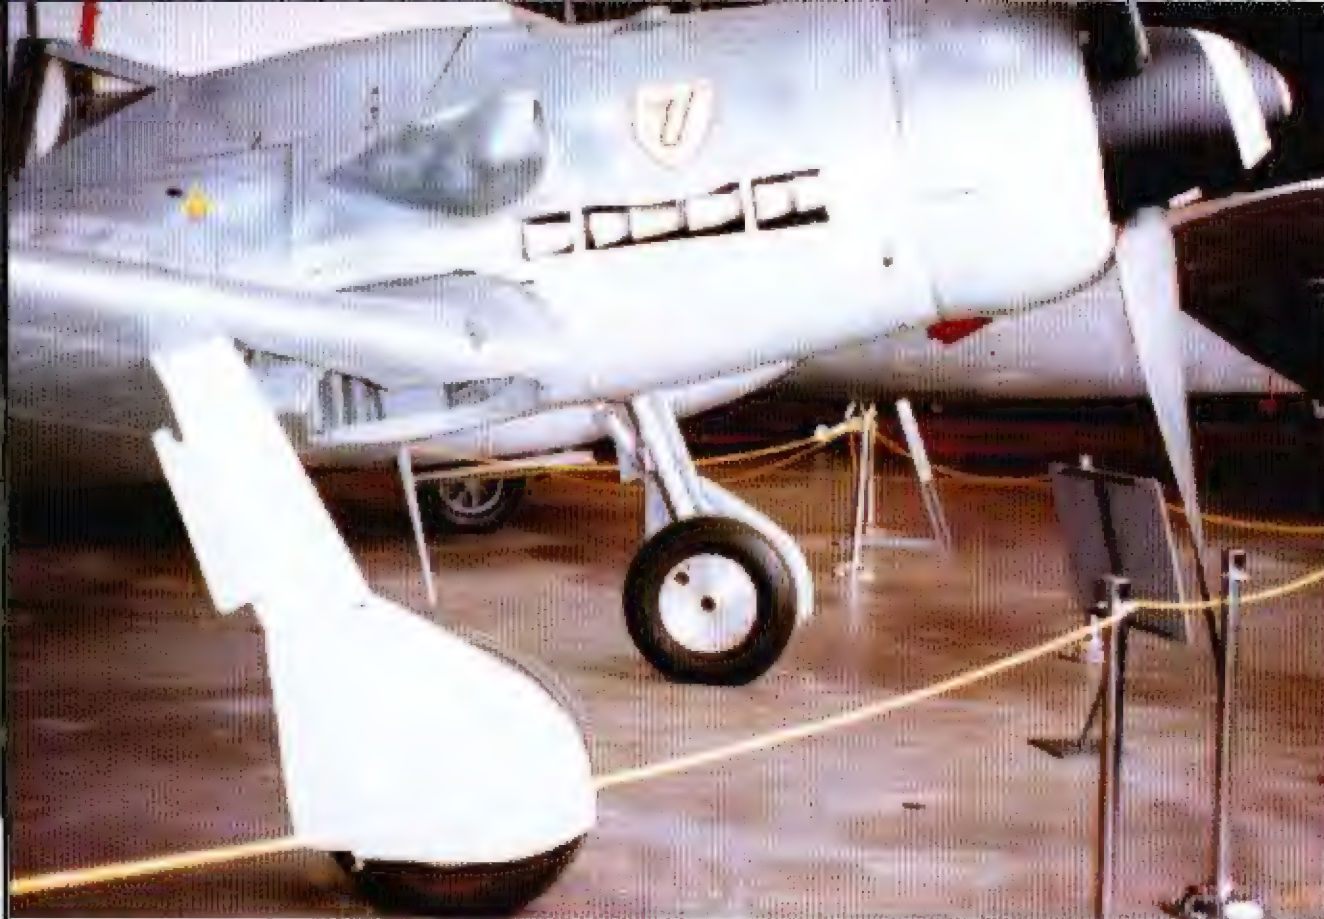
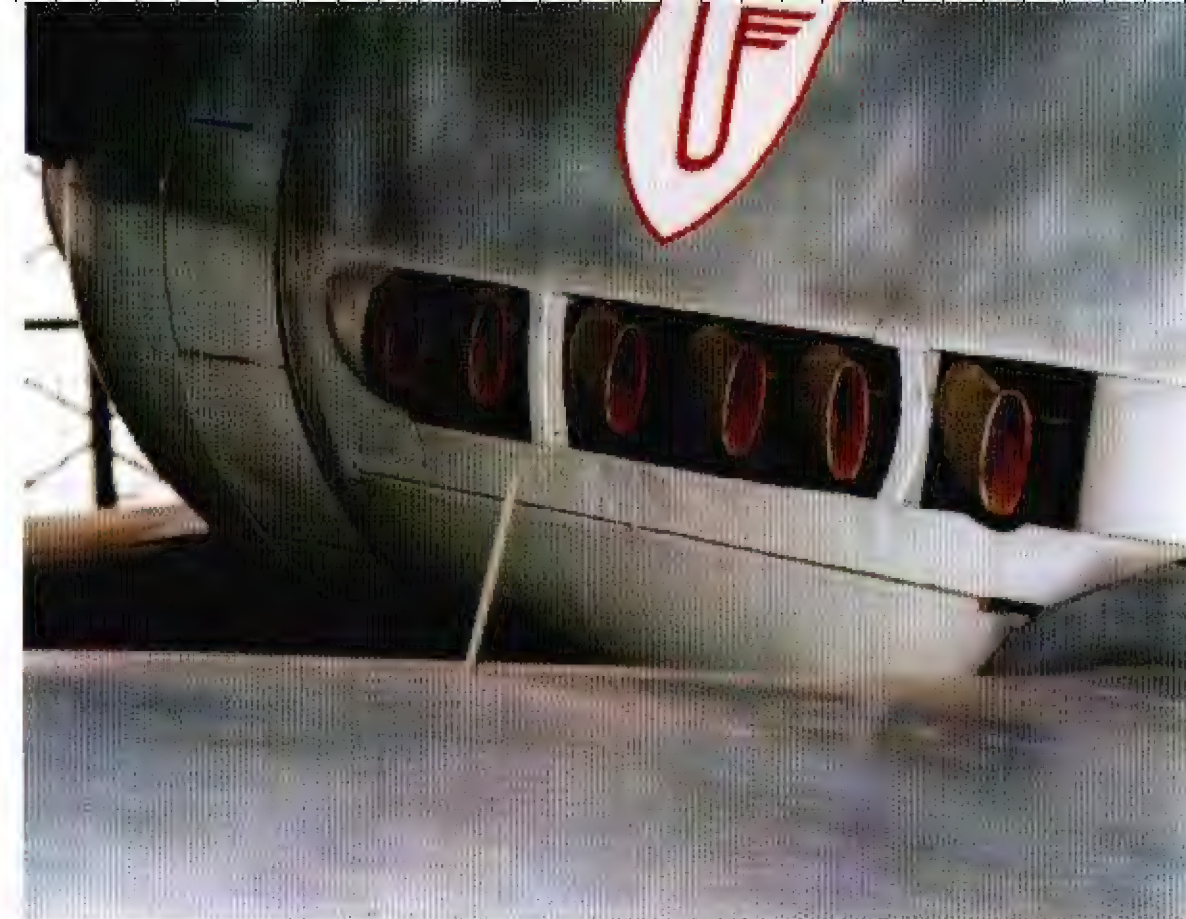
(Above) The oval shaped exhausts pipes have weld lines on both the front and back side of each exhaust. The rod extending upward from the wing top is the visual wheel position indicator rod. The top of the rod is usually painted red over a bottom of white. (J. Bishop)

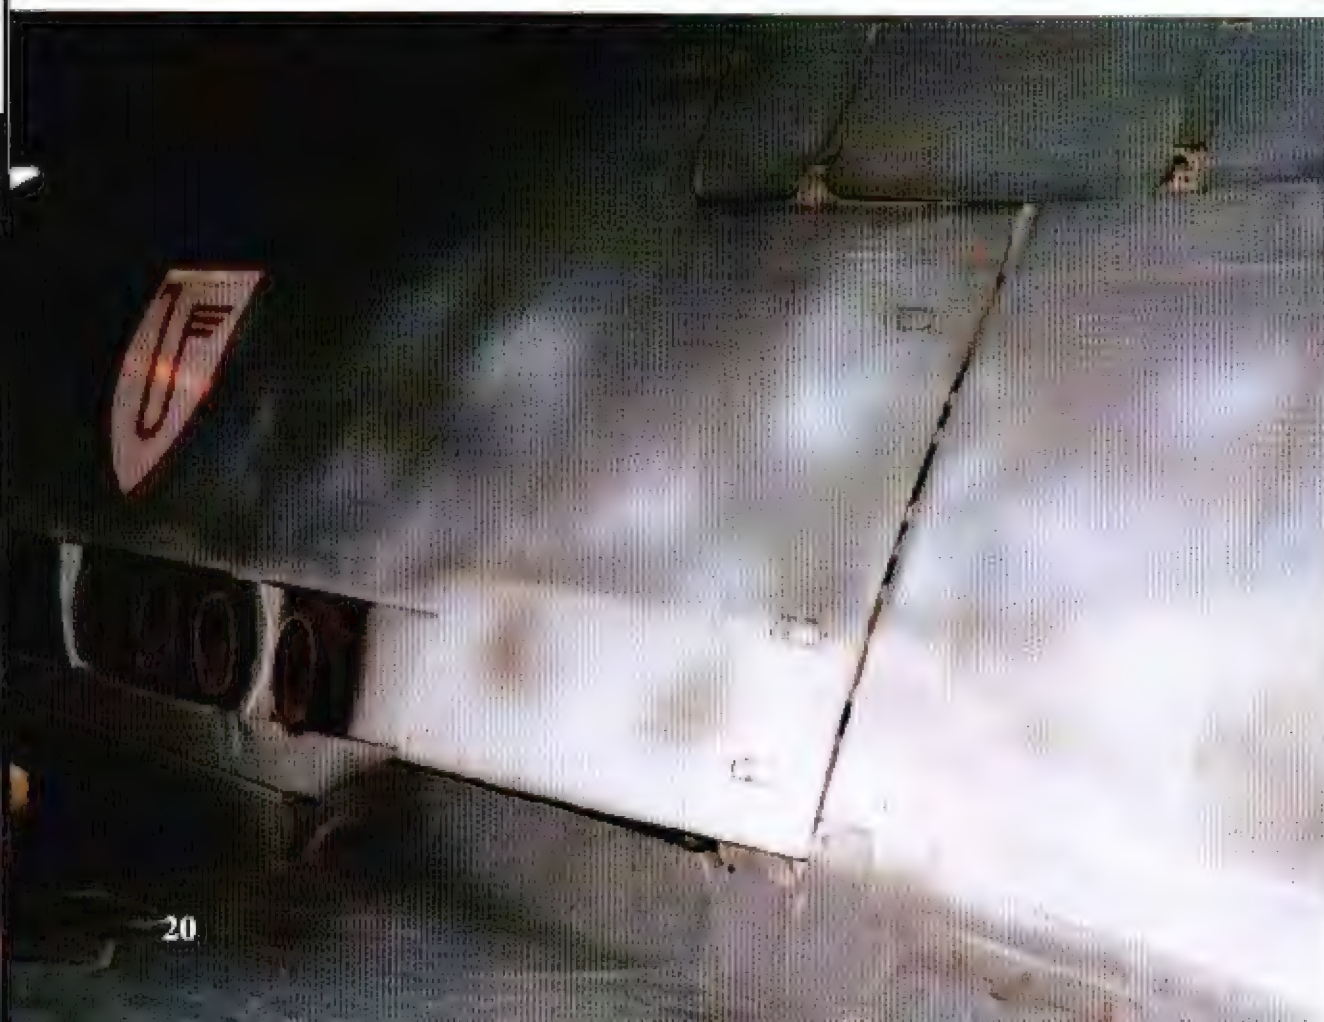
(Above left) The forward starboard side of the Fw 190D-9 displayed at the USAF Museum carries the flying U emblem of JG 3 "Udet". The smooth fit of the in-line engine installed in a radial engine designed airframe is evident. The Jumo 213A engine delivered 1,770 Ps(hp)2 at takeoff. The Fw 190D-9 was capable of 426mph at 21,654ft and had a normal range of 503 miles. (Author: Ryle)

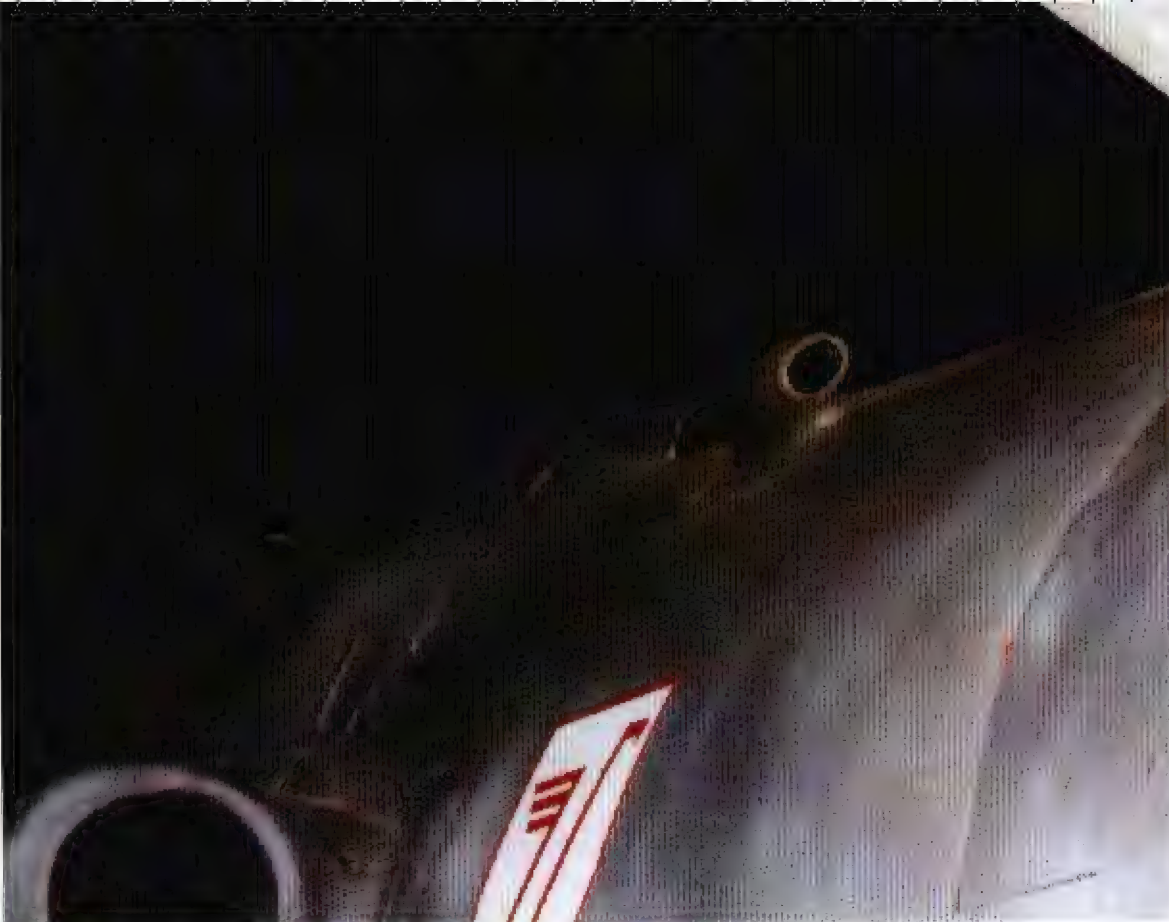
(Left) The poor late war fit of the bulged cowl gun cover panel is obvious and was common to late war Fw 190 aircraft. An external stiffener for D series aircraft has been added to the fuselage just below the cowling gun cover and above the wing root 20mm cannon cover. (J. Bishop)

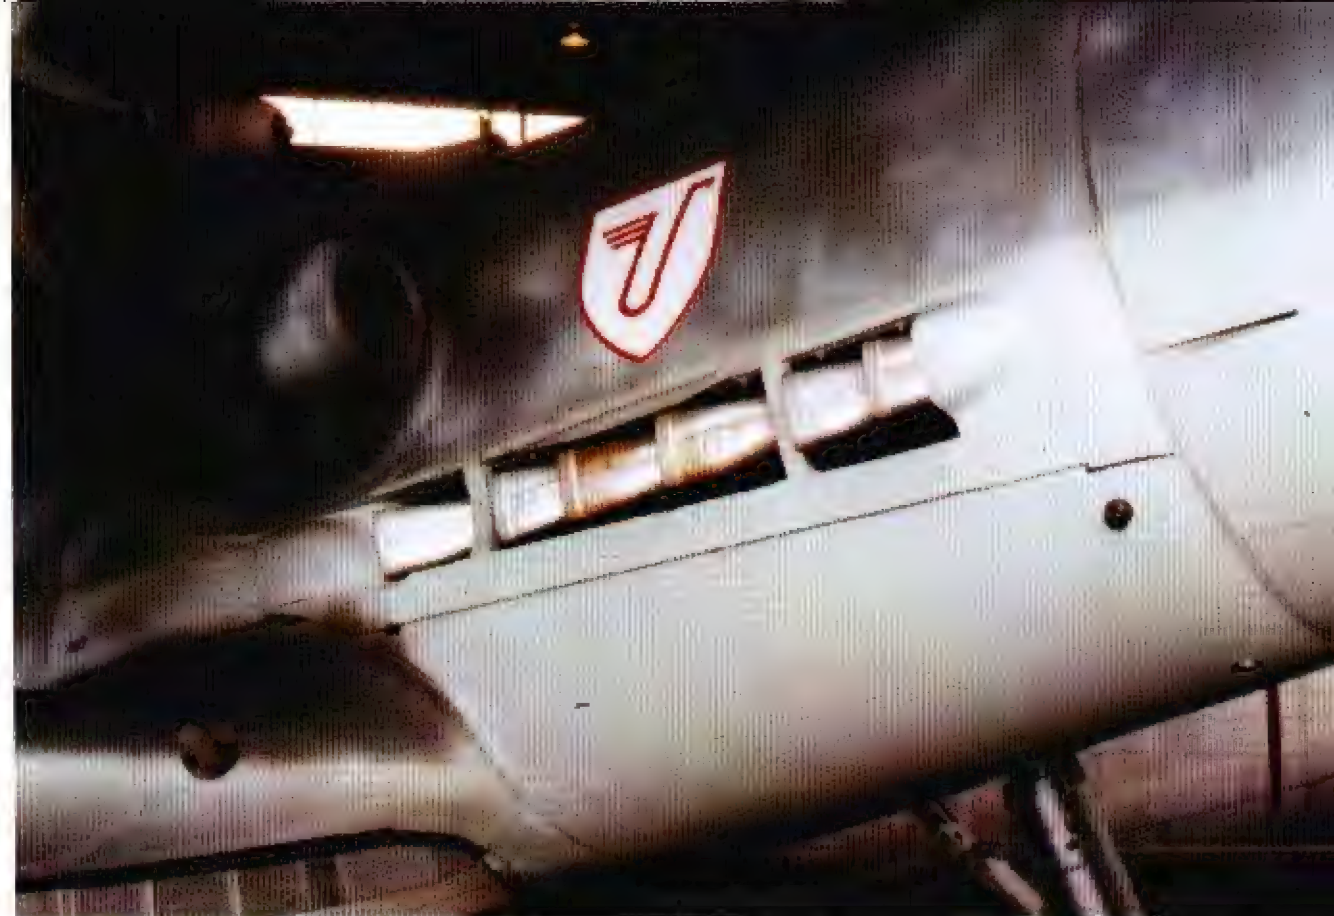
Fresh air for the cockpit was provided by an intake scoop located on the upper starboard rear engine panel in front of and just below the 13mm machine gun port. (J. Bishop)

(Above right) The starboard side of the lower engine cowling just behind the cowl flaps is the coolant overflow pipe. The opening around the exhausts is somewhat larger at the front than at its rear. (J.Bishop)

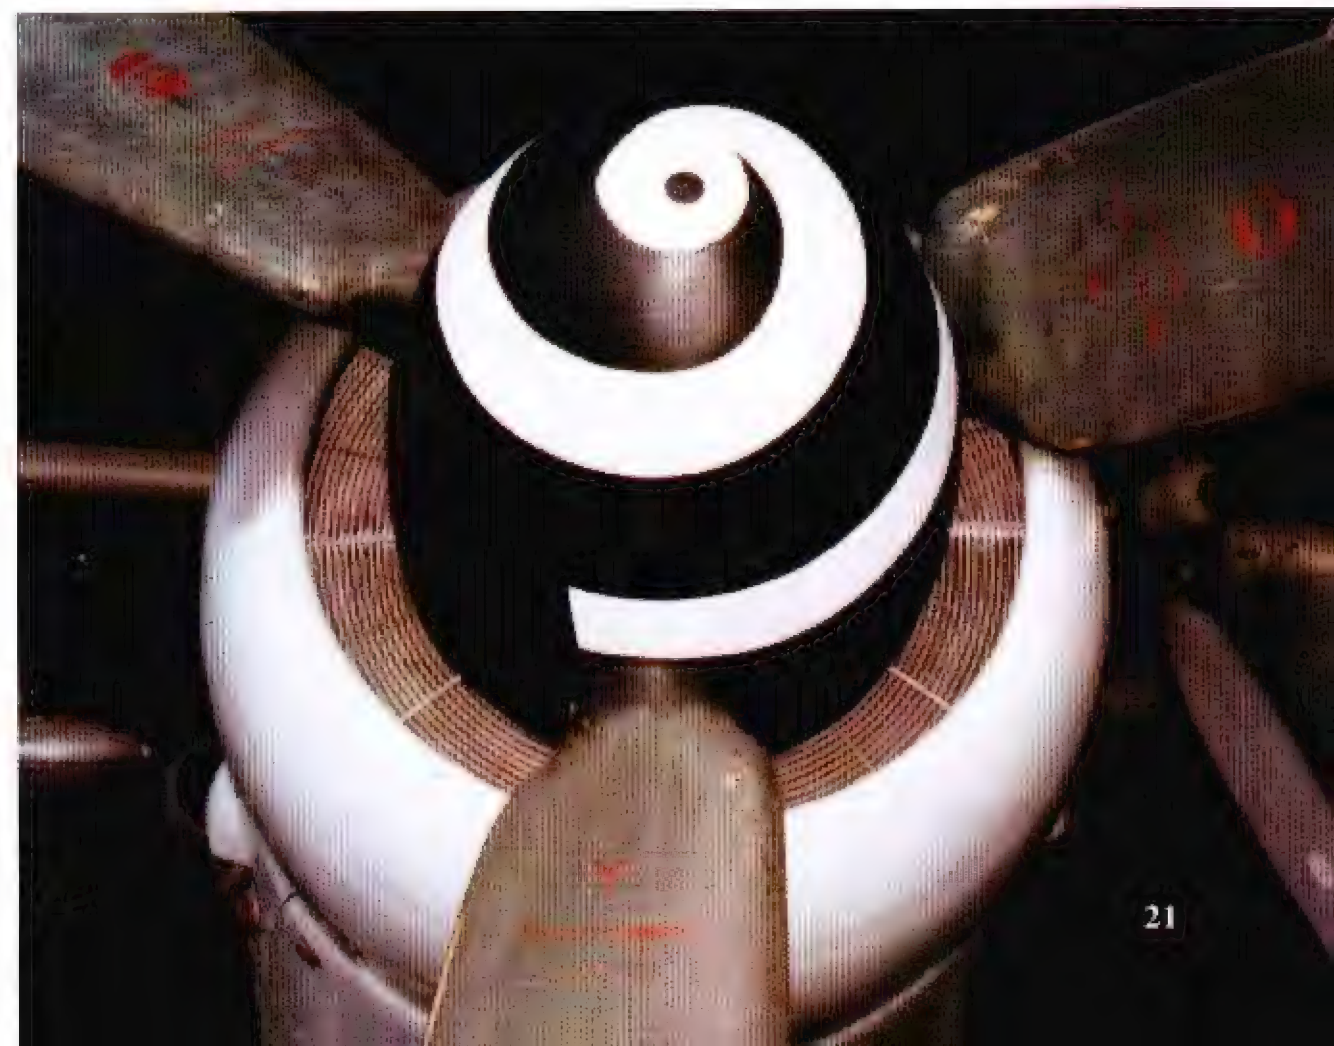
The spinner is a reproduction and the propeller blades are not the VS-111 or VS-9 blades specified for the Fw 190D-9. The circular radiator of the Fw 190D-9 can be seen behind the reproduction spinner. (J. Bishop)

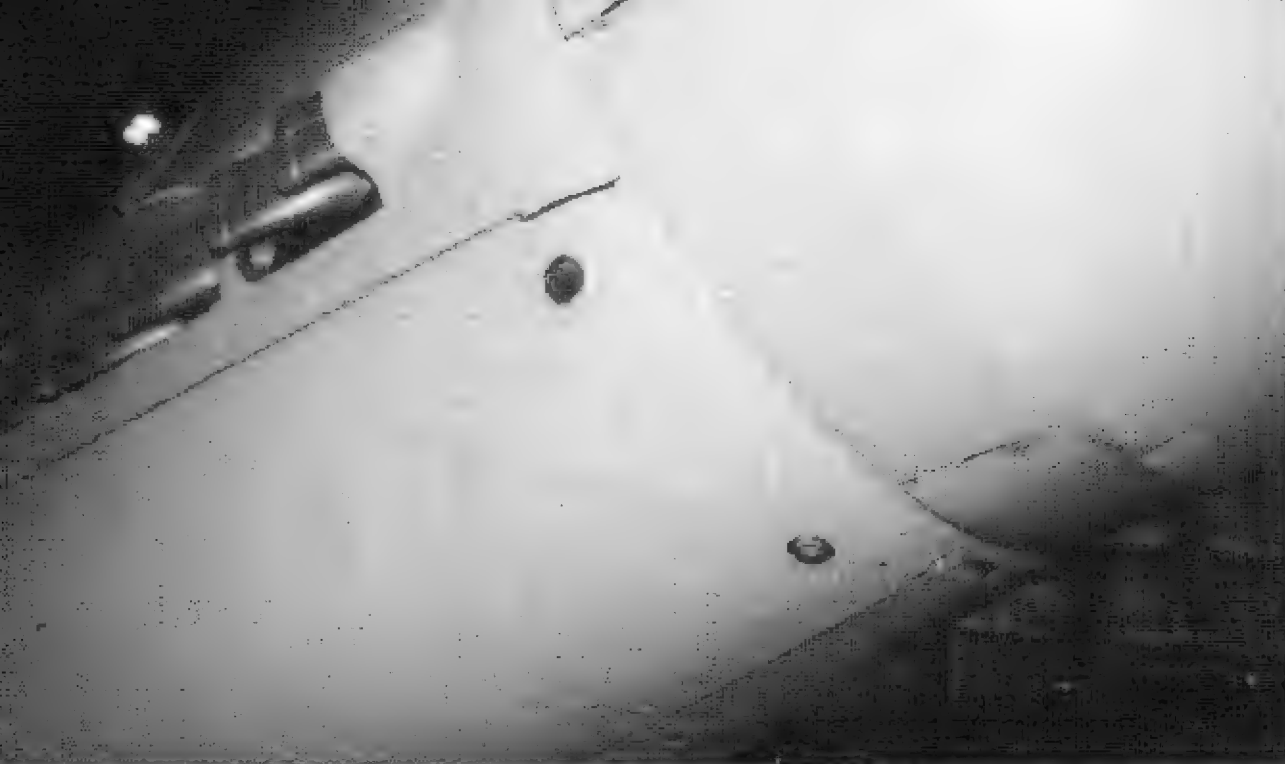
The lower engine cowling is in two panels, the starboard side and the port side with both the coolant and oil overflow lines exiting through the starboard panel. The cowling radiator flaps are fully closed and fit tightly. (J. Bishop)
